EXTERIOR REHABILITATION PLAN FOR HISTORIC HOUSE  
34653 FREMONT BOULEVARD | FREMONT, CA

**SIEGEL & STRAIN** Architects

July 21, 2014

34653 Fremont Boulevard, Fremont, California

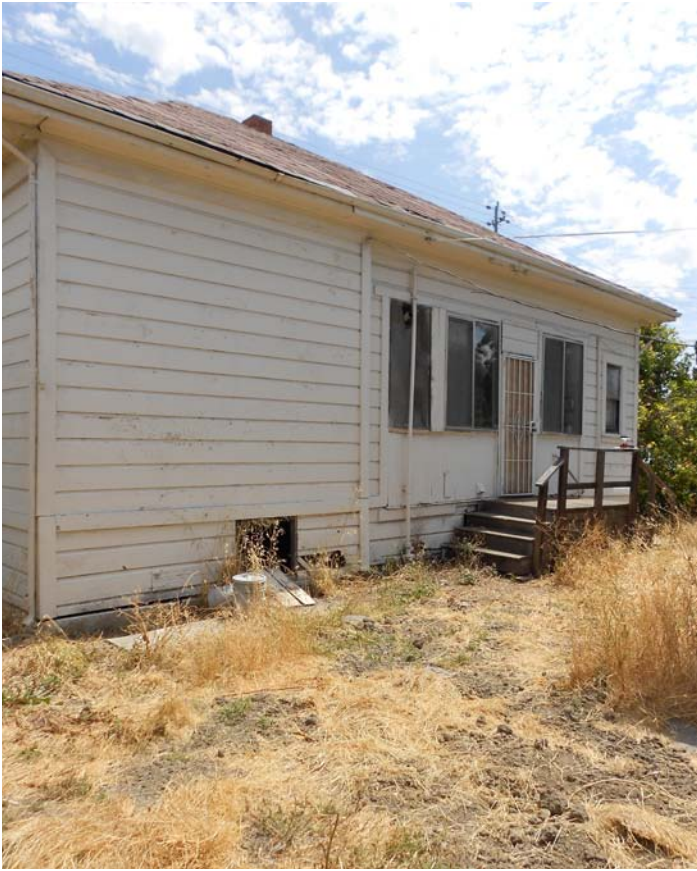
Figure 07: Rear elevation, looking northeast, with broken access door to foundation crawl space. (July, 2014) (S&S)

- › Replace all split, damaged and missing siding and trim boards. Matching original profiles and dimensions.
- › Replace broken access door to crawl space at rear elevation.
- › Patch holes in siding that accommodated prior wires and attachments.
- › Add flashing below siding and trim at locations (such as the bay windows) where moisture penetration has been a chronic problem.
- › Where distance between wood and soil is insufficient, excavate soil adjacent to house to drain away from the structure.
- › Properly prep and paint all wood surfaces

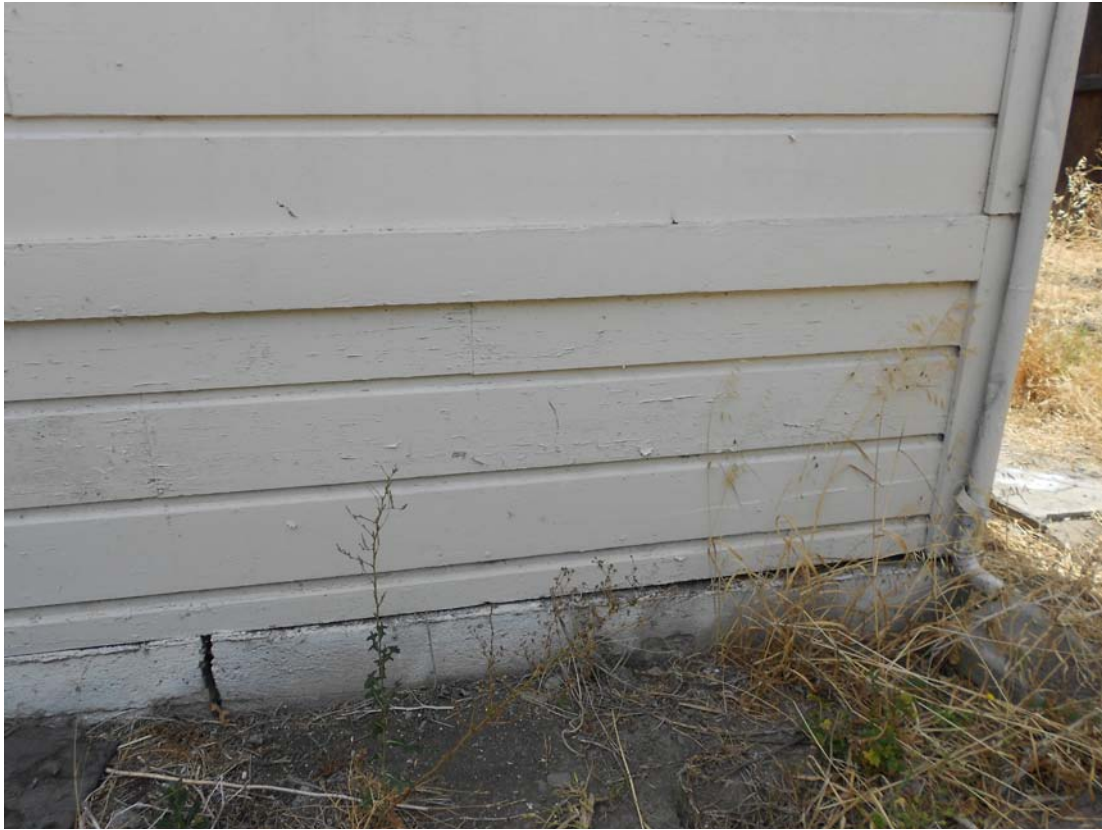
The house is supported on a continuous perimeter concrete foundation that appears to be seriously damaged at several locations, where vertical cracks—up to one inch in width—have opened through the concrete. There is no evidence of steel reinforcing in the concrete. The cracks appear about five feet from the outside corners of the house and appear to be tied to uneven settlement in those areas. The original design and construction of the foundation was very likely under-engineered for the house and soil condition. It also appears to be tied to uncontrolled roof drainage, which may have undermined the footings.

*Figure 10: Detail of south end of west elevation. The open vertical crack through the concrete perimeter foundation appears to be tied to uneven settlement. (July, 2014) (S&S)*

This work will require the expertise of a qualified structural engineer to inspect the existing conditions and design code-compliant repairs and—if required—upgrades.

Remediate the foundation and floor framing as needed to level the floors of the house.

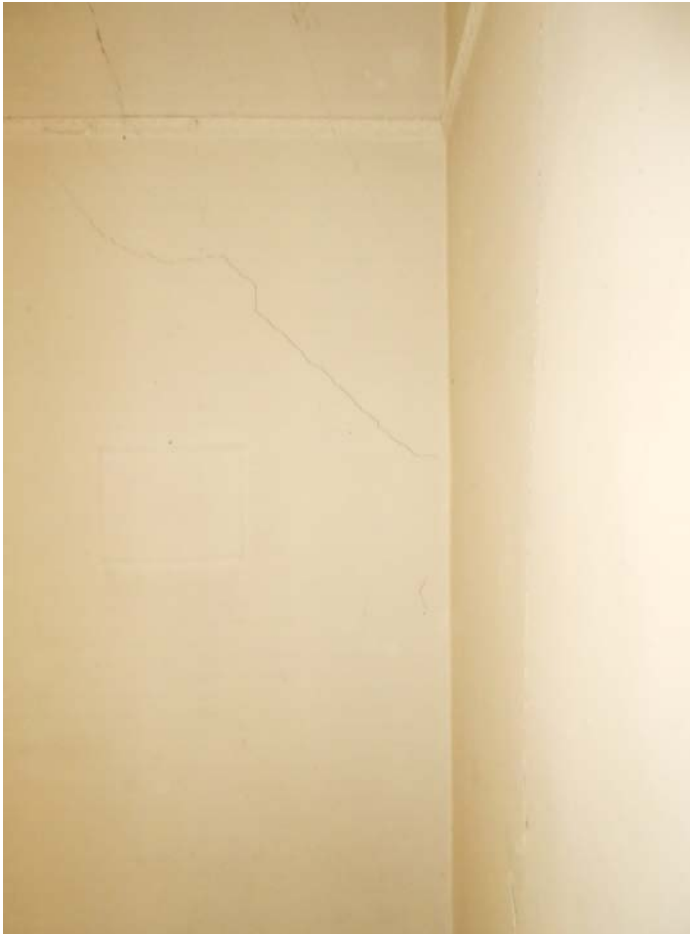
At the interior, there are diagonal cracks in the wall plaster and the floor slopes down toward the exterior corners, confirmed that the house has settled unevenly. This is most apparent at the pantry (southwest corner) and on the west at the bathroom wing.

*Figure 11: Diagonal cracks in interior plaster and sloping floors correspond to vertical cracks through the foundation. (July, 2014) (S&S)*

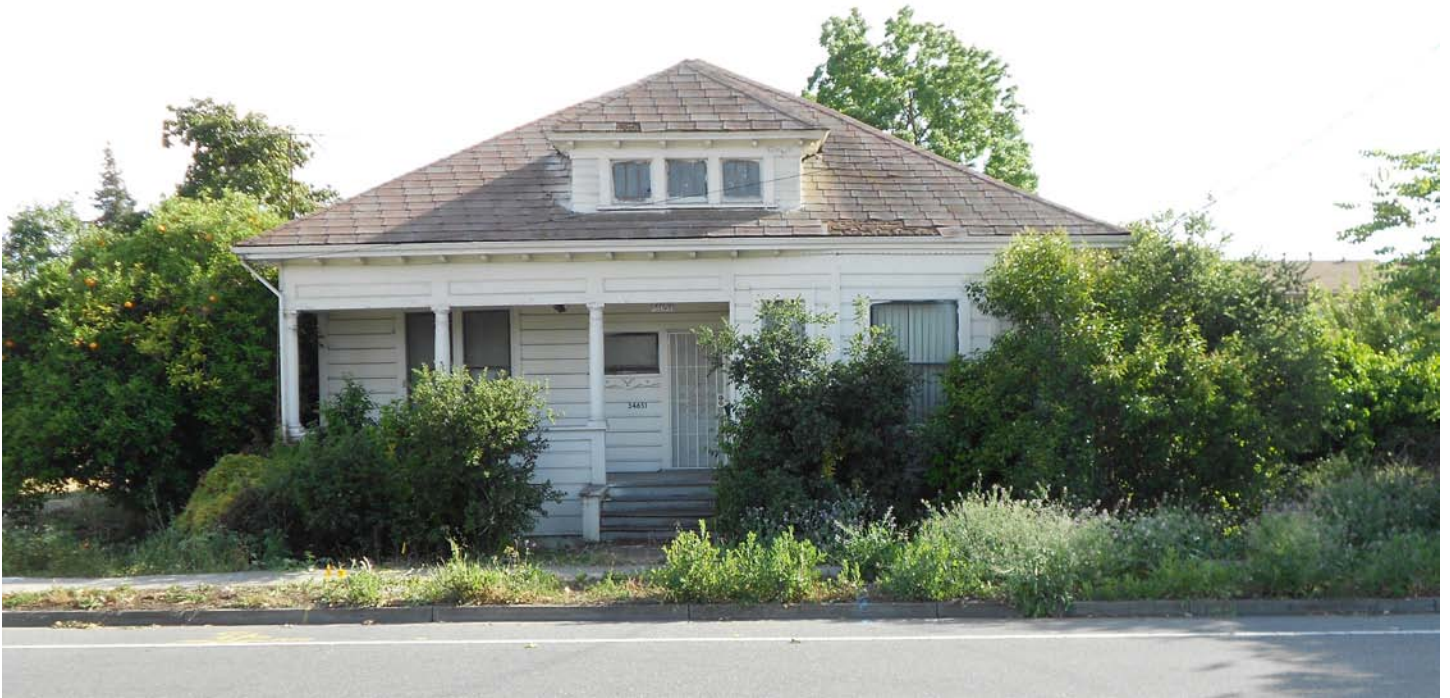
The roof, sheathed in multiple layers of composition shingles is currently in very poor condition. Large areas of the roof shingles are missing. The roof penetrations—brick chimney, dormer, exhaust pipes—are inadequately flashed. Metal gutters, not original to the house, are clogged and undersized at some locations. Downspouts, some of them broken, are not tied to the storm system.

Figure 12: Roof shingles are missing from areas of the roof including the north side of the main roof and dormer roof. (July, 2014) (S&S)

- › Remove all built up layers of shingles
- › Verify that wood sheathing and roof framing members are sound. This will require the expertise of a qualified structural engineer, who may recommend applying plywood sheathing at roof for shear.
- › Properly flash roof and all roof penetrations—brick chimney, dormer, exhaust flues.
- › Re-roof with new shingles.
- › Replace existing gutters and downspouts with new gutters and downspouts sized to efficiently remove rainwater especially above the bay windows.
- › Tie downspouts to storm water system.
- › Clear gutters of debris on a regular basis.

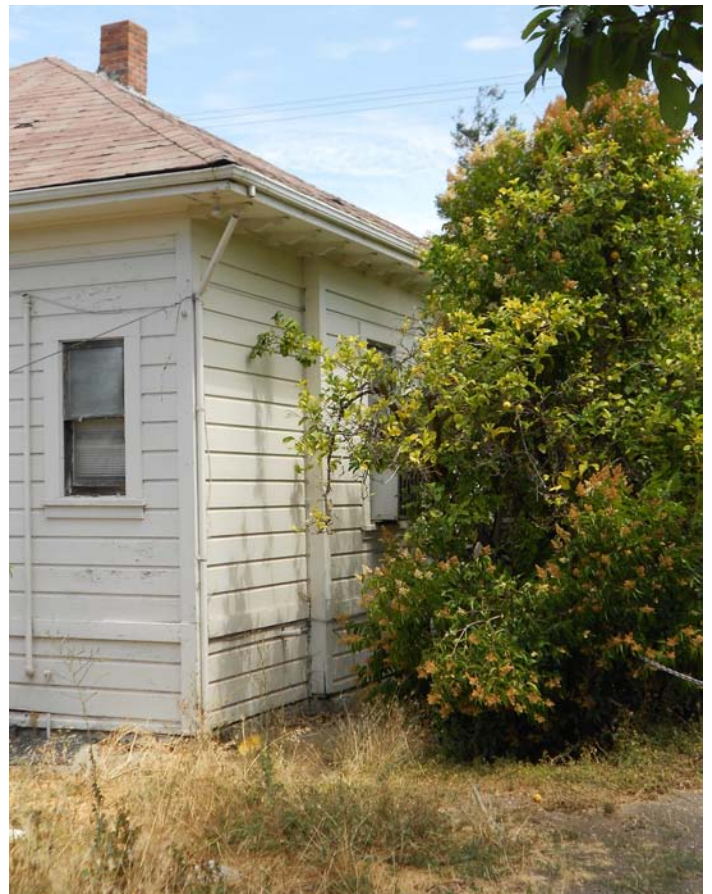
Figure 14: Southeast corner with detached downspout. (July, 2014) (S&S)

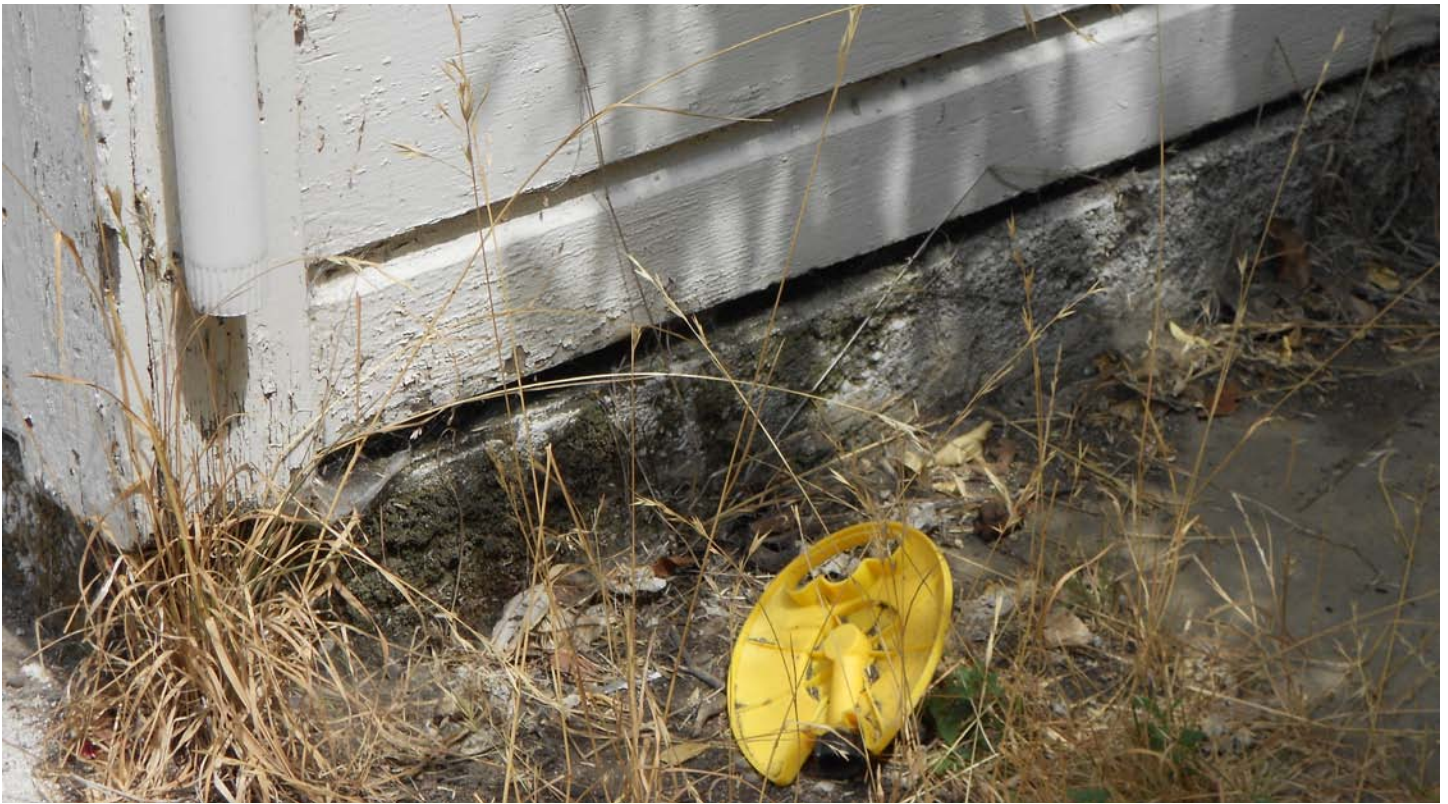
Figure 15: Detail of southeast corner showing moss growing on the concrete foundation. Downspouts are not tied to the storm water system and have contributed to foundation damage. (July, 2014) (S&S)

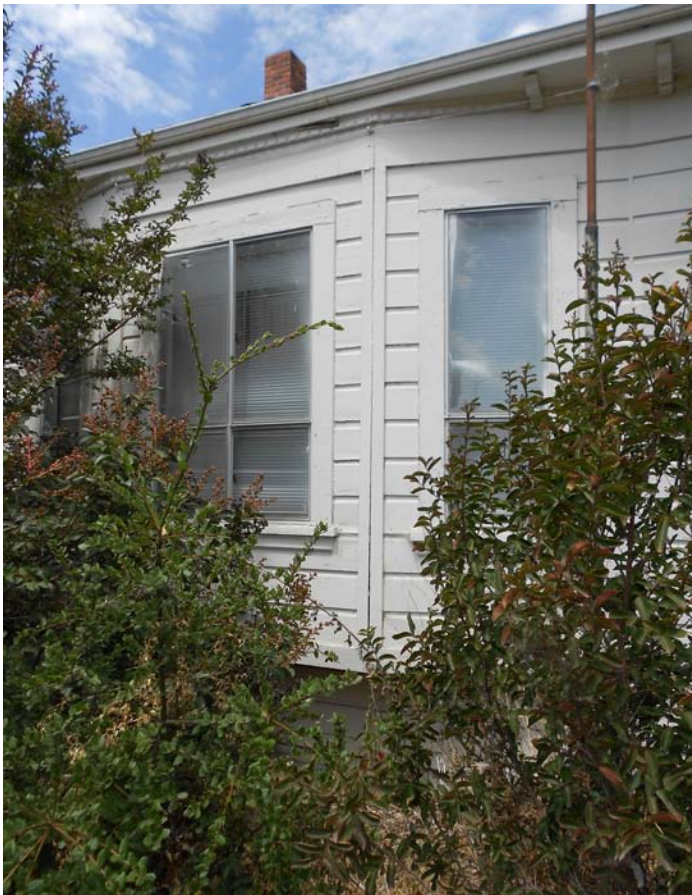
Another design flaw that appears to date from the original construction is the inadequate roof overhang above the shallow bay windows, particularly on the east side of the house, which is subjected most heavily to wind-driven rain. This can be remediated by replacing the existing metal gutter, added after the period of significance, with a wider gutter that is cleared of debris on a regular basis.

Figure 16: Detail of bay window at east elevation, where roof overhang is not sufficient to protect it from rain. Original wood windows have been replaced with aluminum sash in this location. (July, 2014) (S&S)

- › Repair and refurbish all wood sash windows to operable condition. Where windows are too deteriorated for repair, replace with new (custom made) or salvaged wood sash windows that match the originals in all details.
- › Replace all aluminum sash windows with new (custom made) or salvaged wood sash windows that match the originals in all details. Replace rear porch windows with multi-pane wood windows that match the one intact window at west end.
- › Repair wood casings and sills. Where these are too deteriorated for repair, replace with new or salvaged material matching the originals in all details.

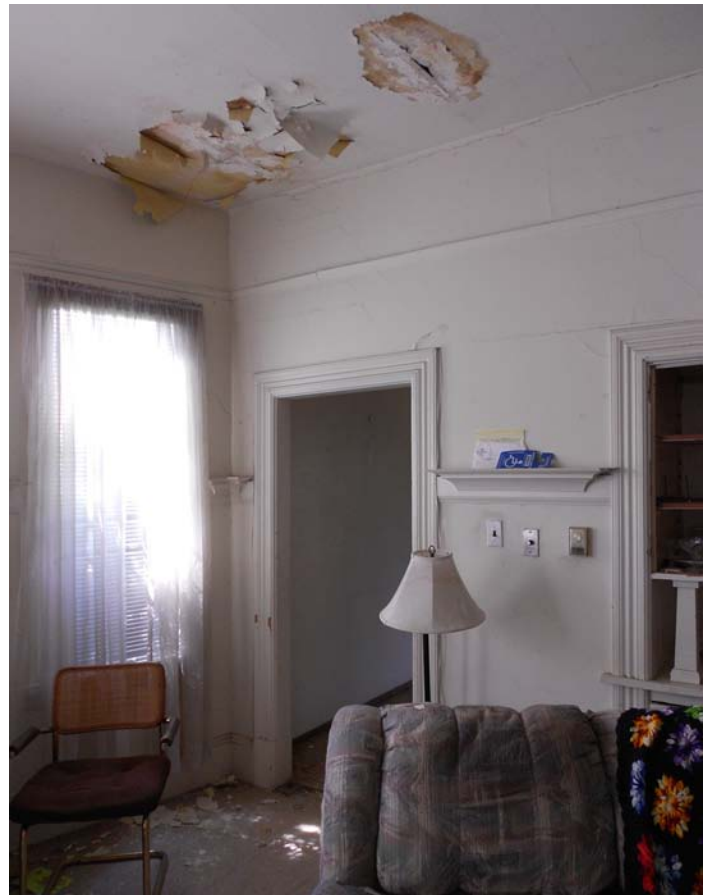
Figure 17: Detail of interior ceiling plaster damaged by water infiltration at bay window on east elevation, looking southeast (see also Figure 16). (July, 2014) (S&S)

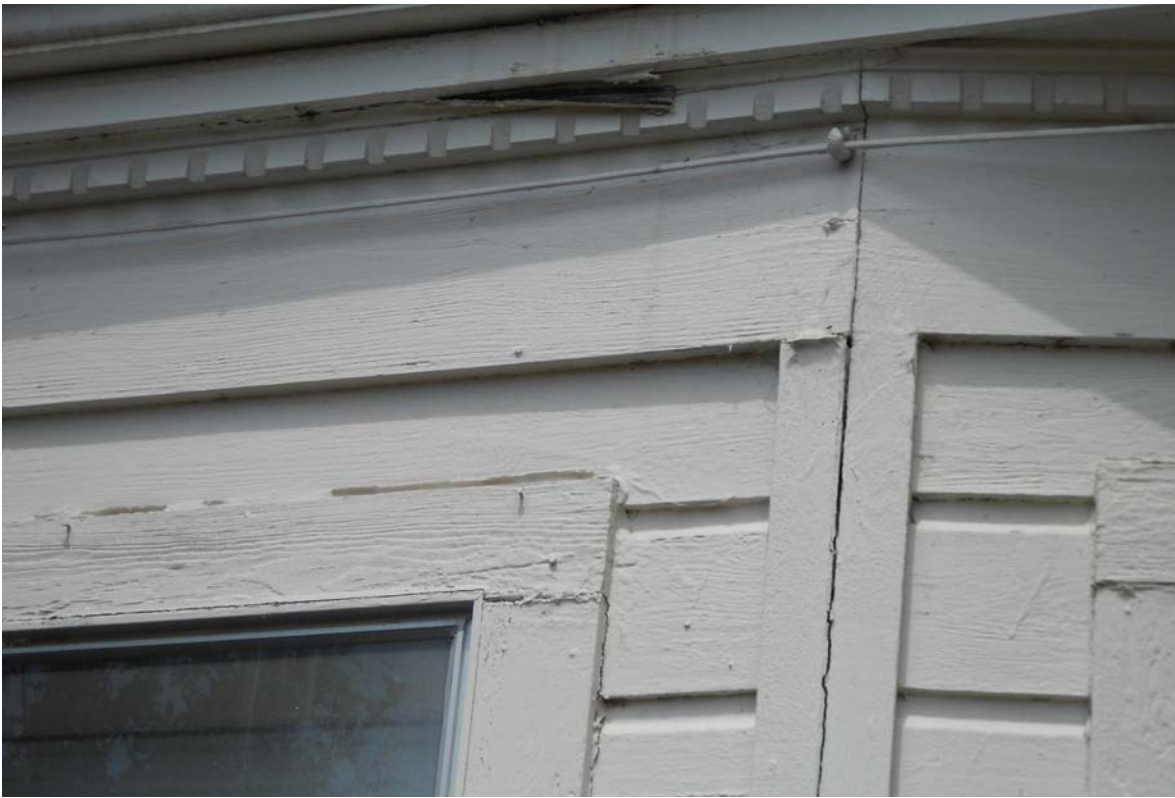
Figure 18: Detail of bay window at east elevation. Rain water is able to enter the structure through open joints in the wood trim and can lead to damage of interior finishes and wood structural members. (July, 2014) (S&S)

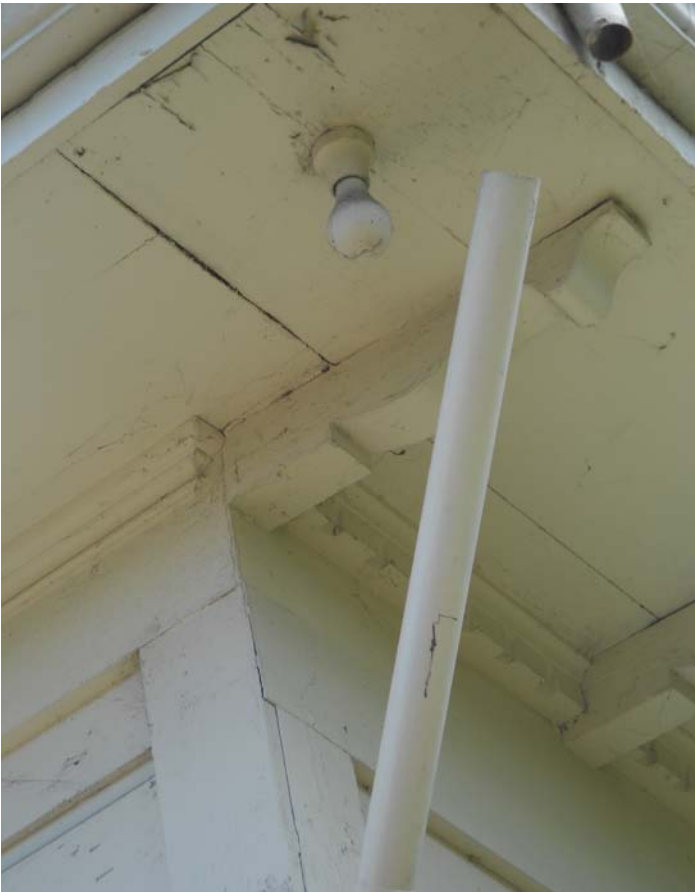
Figure 19: Detached downspout at southeast corner of the house has led to damage of the soffit board and light fixture. (July, 2014) (S&S)

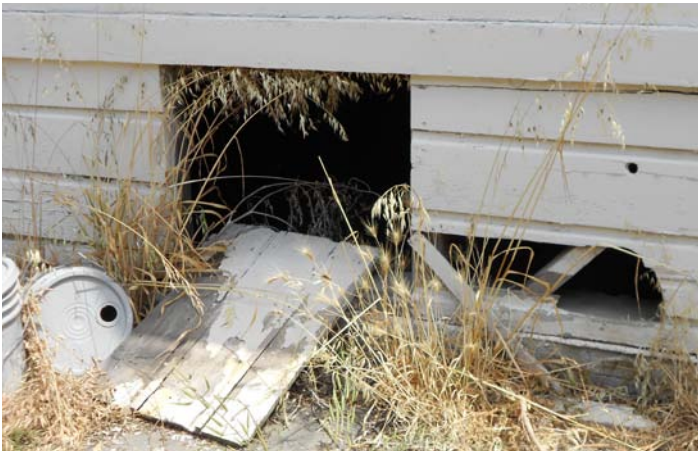
Figure 20: Broken access door to foundation crawl space and missing wood siding at rear elevation. (2014) (S&S)

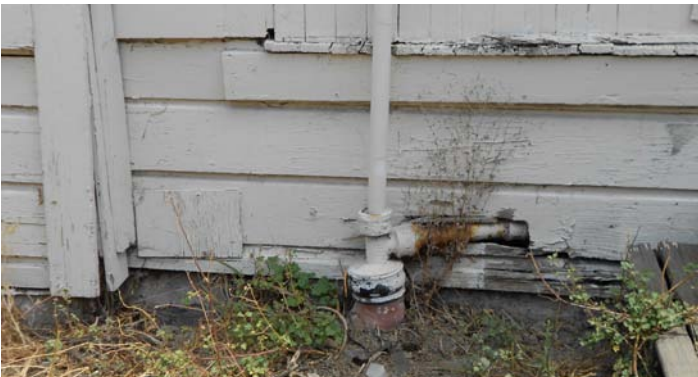
Figure 21: Detail of rear elevation below enclosed porch. Exposed pipe serves water heater on porch. Relocation of water heater and pipe is recommended. (July, 2014)

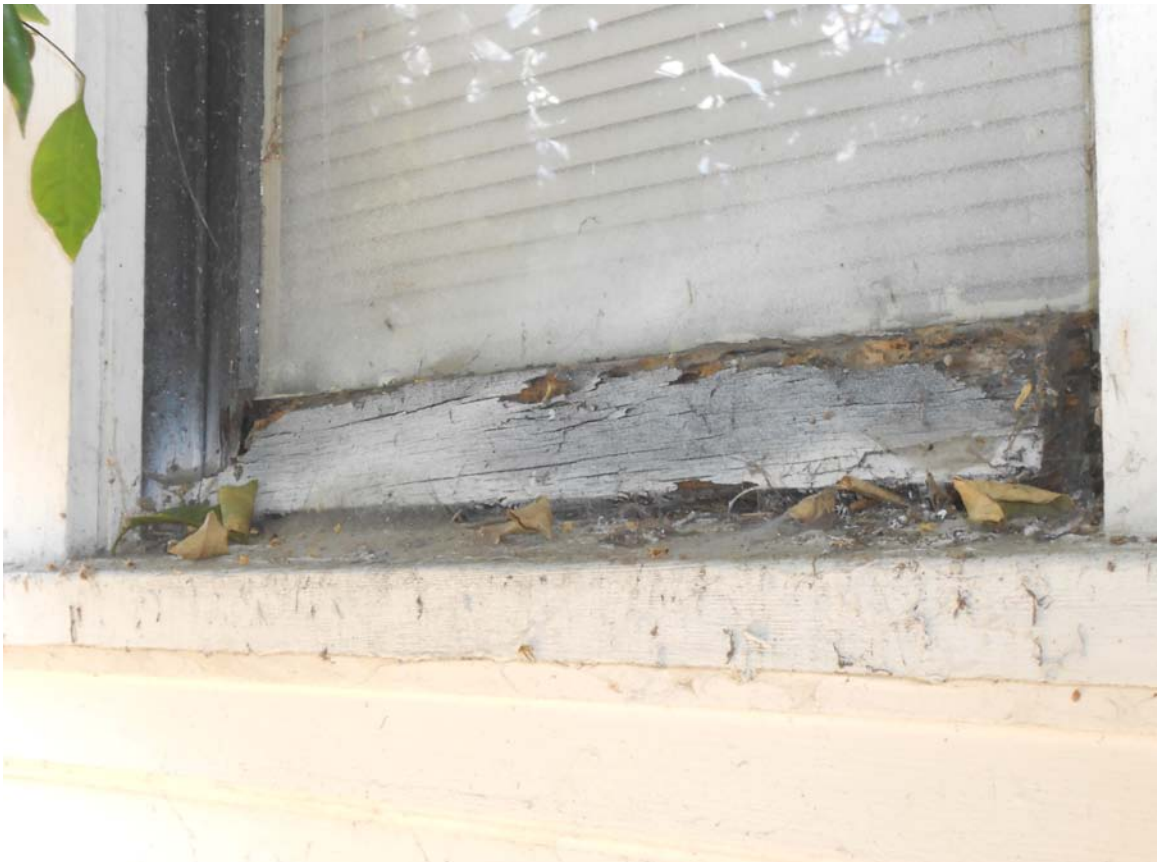
While many of the historic wood sash windows are intact, some of these are in poor condition. Damage is most evident at the bottom rails. Some windows have been replaced with aluminum sash, which is incompatible with the historic character of the house.

*Figure 25: Damaged bottom rail at wood sash window on east elevation. Wood windows should be refurbished, and where necessary, rebuilt to match original wood windows. (July, 2014) (S&S)*

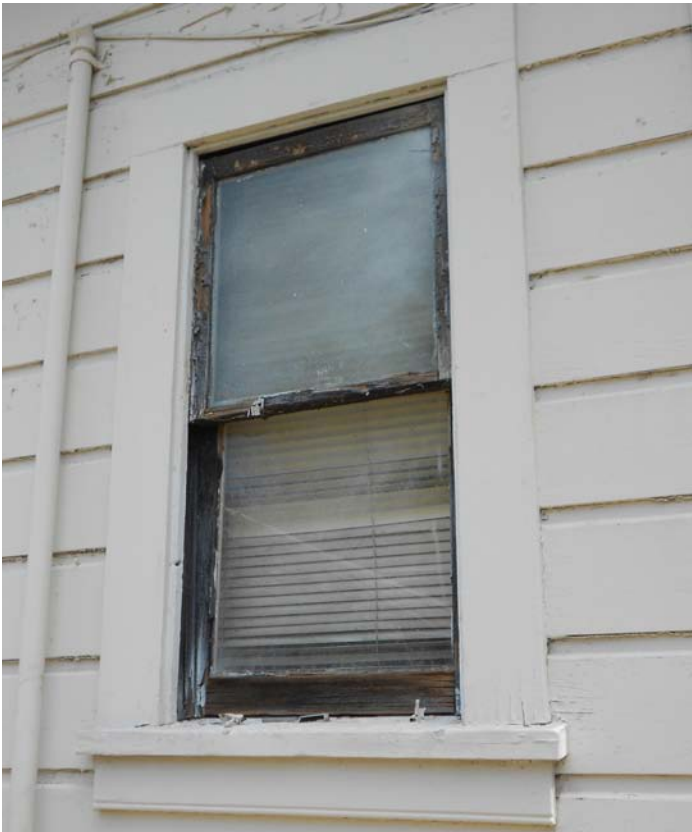
*Figure 26: Wood window at rear elevation was damaged during a recent break-in. Wood windows should be refurbished, or where necessary, rebuilt to match original wood windows. (July, 2014) (S&S)*

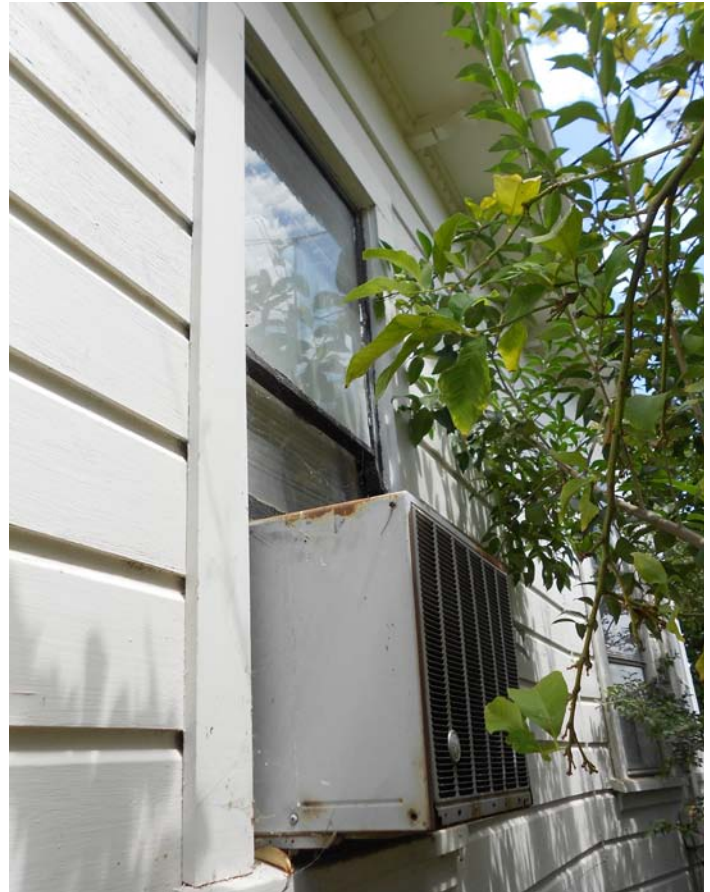
*Figure 27: Window air conditioning unit on east. (July, 2014) (S&S)*

- › Remove abandoned surface mounted electrical wires and equipment and patch holes.
- › Removed abandoned hose bibs
- › Remove abandoned exhaust flues
- › Remove abandoned surface mounted telephone equipment and wires and patch holes.
- › Remove abandoned metal attachments and patch surface.
- › Relocate meters to less visible location or conceal in wood cabinet.
- › Remove window air conditioning unit on east.
- › Remove antennae from east side of the house.

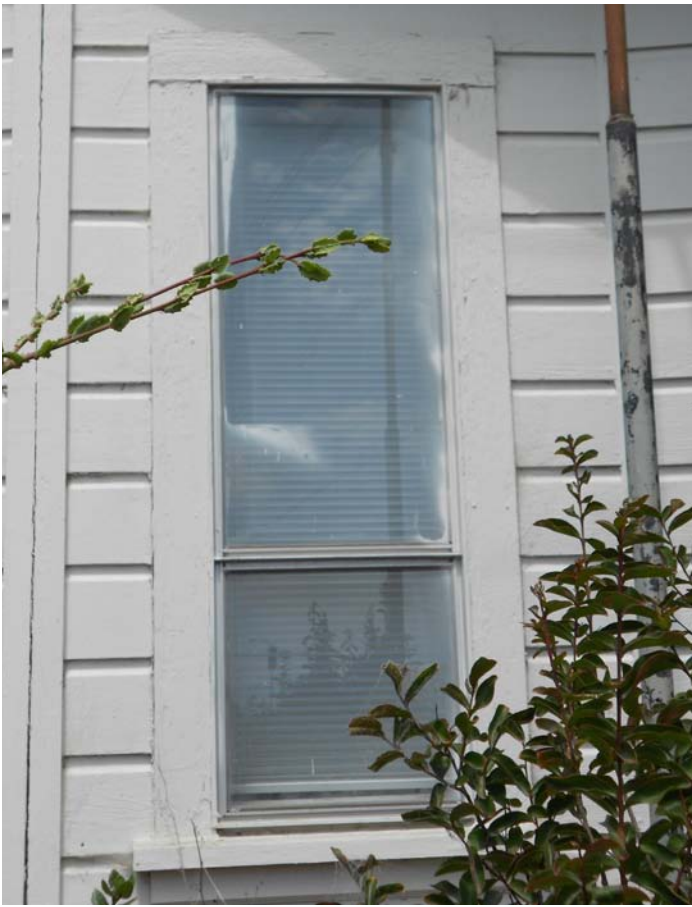
Figure 28: Asymmetrical aluminum sash replacement windows are not in character with the historic house and should be replaced with wood sash windows matching the originals. (July, 2014) (S&S)

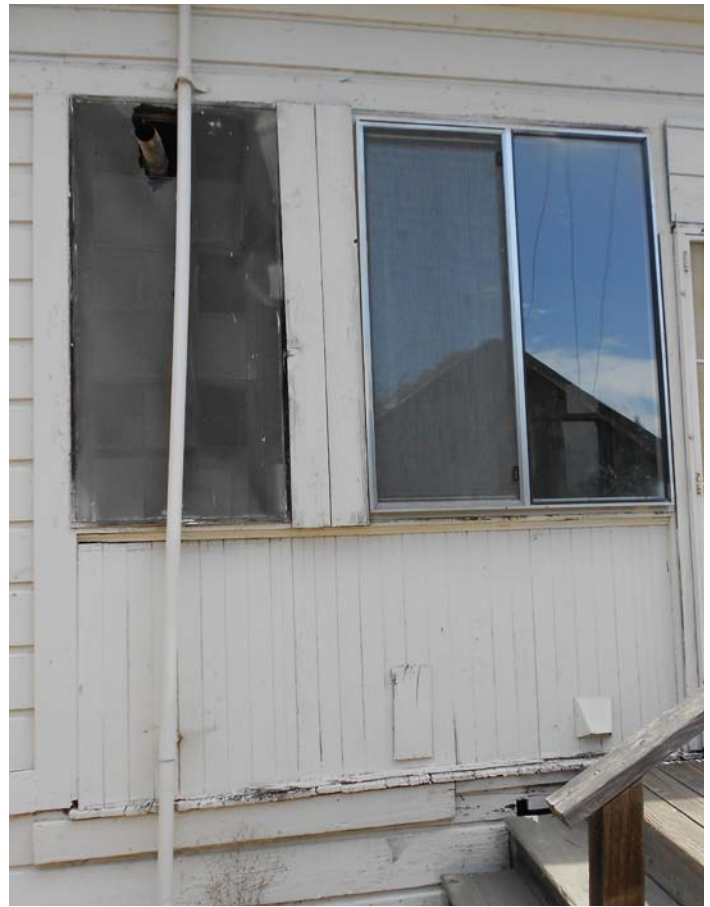
Figure 29: Detail of enclosed rear porch with historic multi-pane window at left behind pipe and aluminum slider replacement window at right above tongue and groove infill wall. (July, 2014) (S&S)

- › Rebuild infill walling with vertical tongue and groove siding below multi-paned wood sash to match the historic infill.
- › Flash exposed end of wood floor to protect from moisture and insects.
- › No documentation of the original stairs was found during this project. Replace existing stair and landing with painted wood stair designed to meet current code.
- › Retain original exterior siding, trim, window and doors at porch interior.
- › Replace badly worn wood floor boards, but retain all sound boards. Match the dimensions of the existing floorboards.

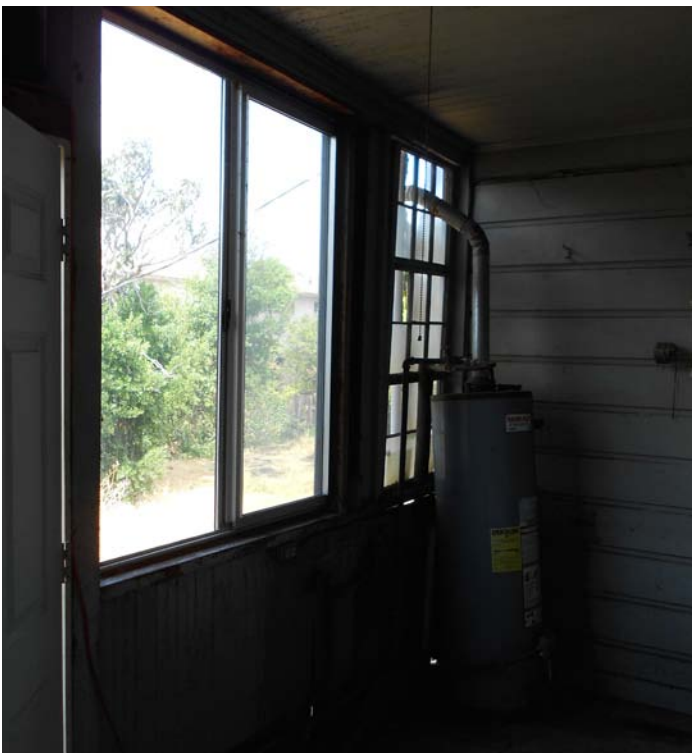
Figure 30: Infill wall viewed from the interior of the enclosed porch with historic multi-pane window at right. Infill wall and windows are in poor condition and should be rebuilt with multi-pane windows that match the historic windows. (July, 2014) (S&S)

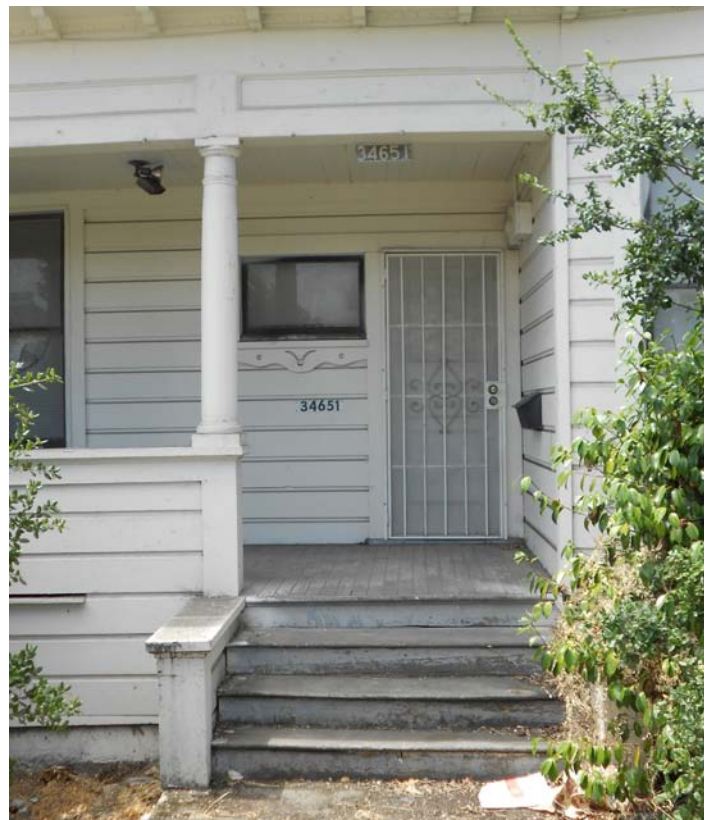
Figure 31: Wood steps leading to front porch and entry are worn and have pulled away from the house. They should be rebuilt matching original and securely attached to the structure. (July, 2014) (S&S)

- › Replace badly worn wood floor boards between the entry and stairs. Match the dimensions of the existing floorboards. Leave sound boards in place.
- › Rebuild stairs to match existing and secure them to the structural frame of the house.
- › Prepare all painted surfaces and repaint.

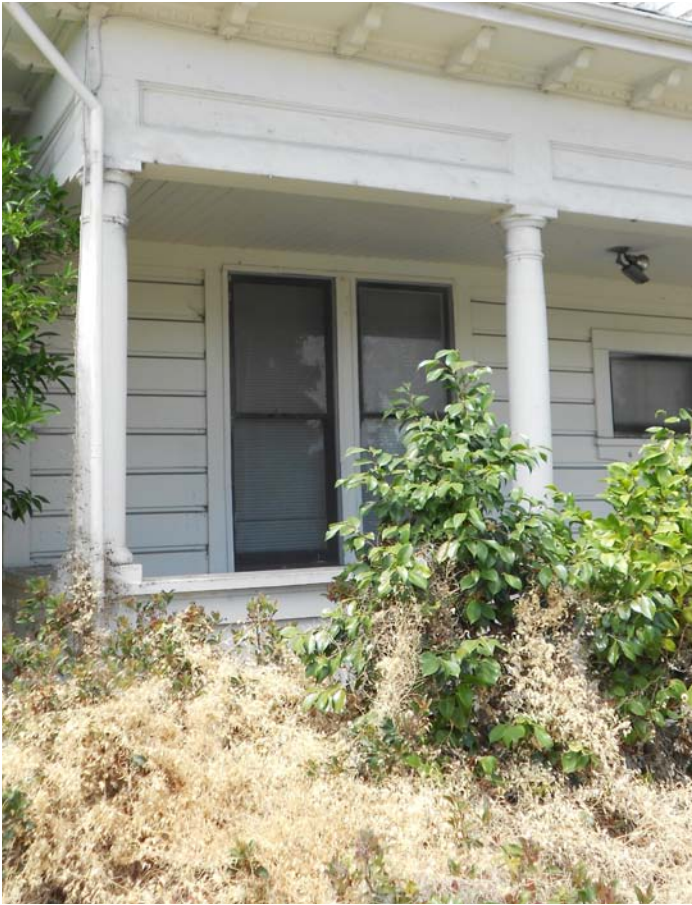
Figure 32: Detail of front elevation showing overgrown vegetation adjacent to front porch. (July, 2014) (S&S)

- › Cut back overgrown vegetation adjacent to the structure.
- › Vegetation holds moisture against the wood siding and accelerates its deterioration. It also provides habitat for wood damaging insects and animals. It also causes abrasion and impact damage.
- › Trim and maintain vegetation adjacent to the structure (especially at northwest corner of house) to enhance visibility from public street and sidewalk.
- › Retain sufficient spatial openness surrounding the house to convey the property's single-family residential use.
- › Retain historic concrete path between public sidewalk and front porch and partially encircling the house. Replace in kind in areas where missing.
- › Plant vegetation to visually buffer the house from new construction at the site.

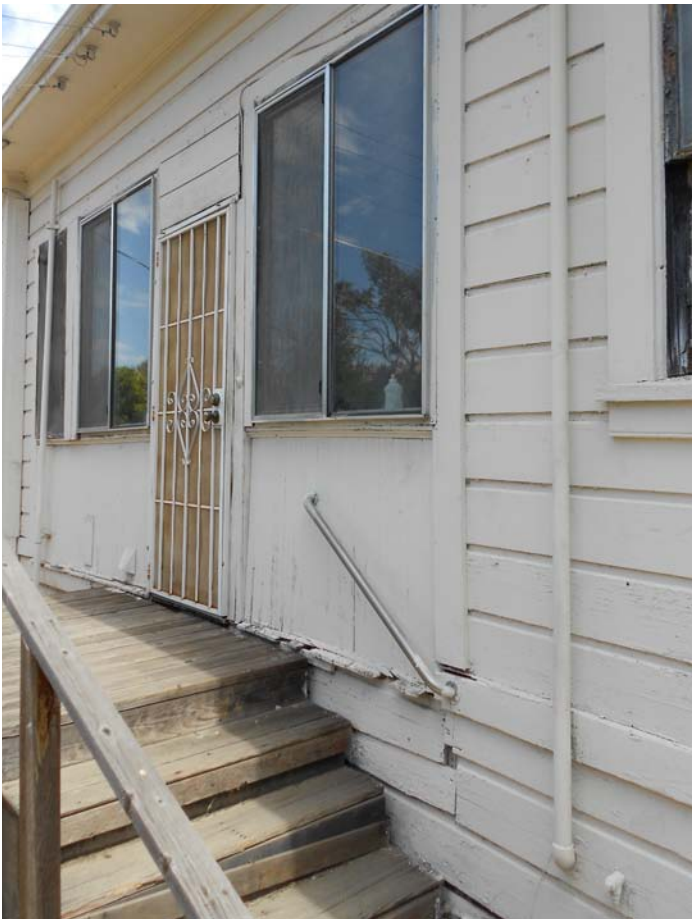
Figure 36: Detail of unpainted wood stairs and landing, in poor condition, with rear porch infill wall beyond. The stairs and landing were built after the period of significance and should be replaced with code compliant stair and rails painted like the house. (July, 2014) (S&S)

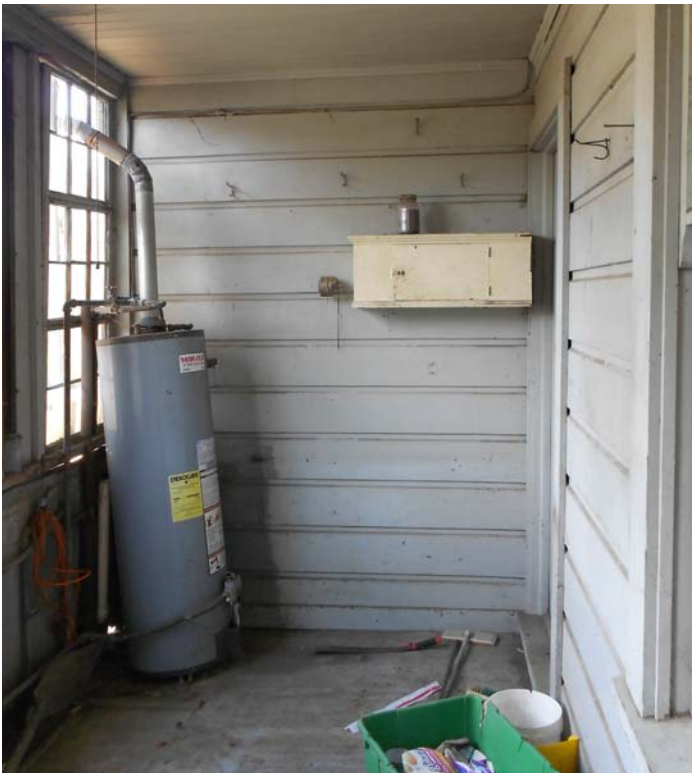
Figure 38: Enclosed rear porch looking west. Water heater, which exhausts through the historic multi-pane window, should be relocated and exhaust through the roof. (July, 2014) (S&S)

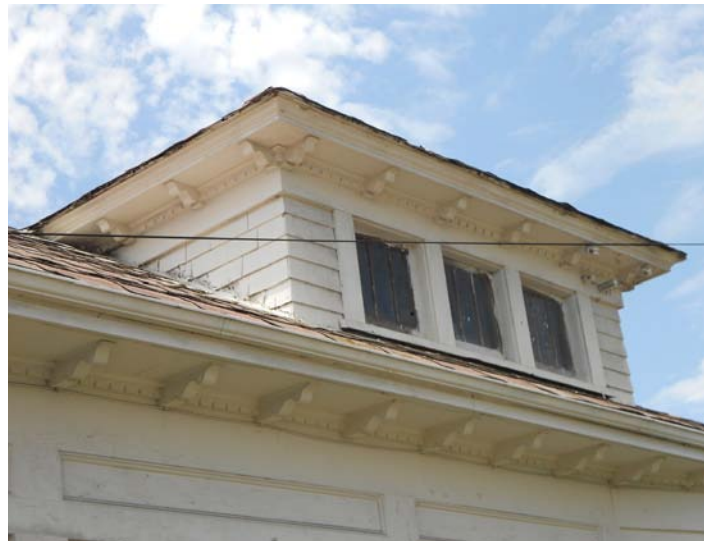
Figure 39: Detail of front eaves and dormer. Roof is in poor condition and requires replacement and flashing of roof penetrations including the dormer, brick chimney, and exhaust pipes. (July, 2014) (S&S)

- › Flash chimney at roof penetration.
- › Where the mortar is missing or in a deteriorated condition, repoint the brick using a mortar that matches the original in strength and color.
- › Ensure that the chimney remains in working condition.

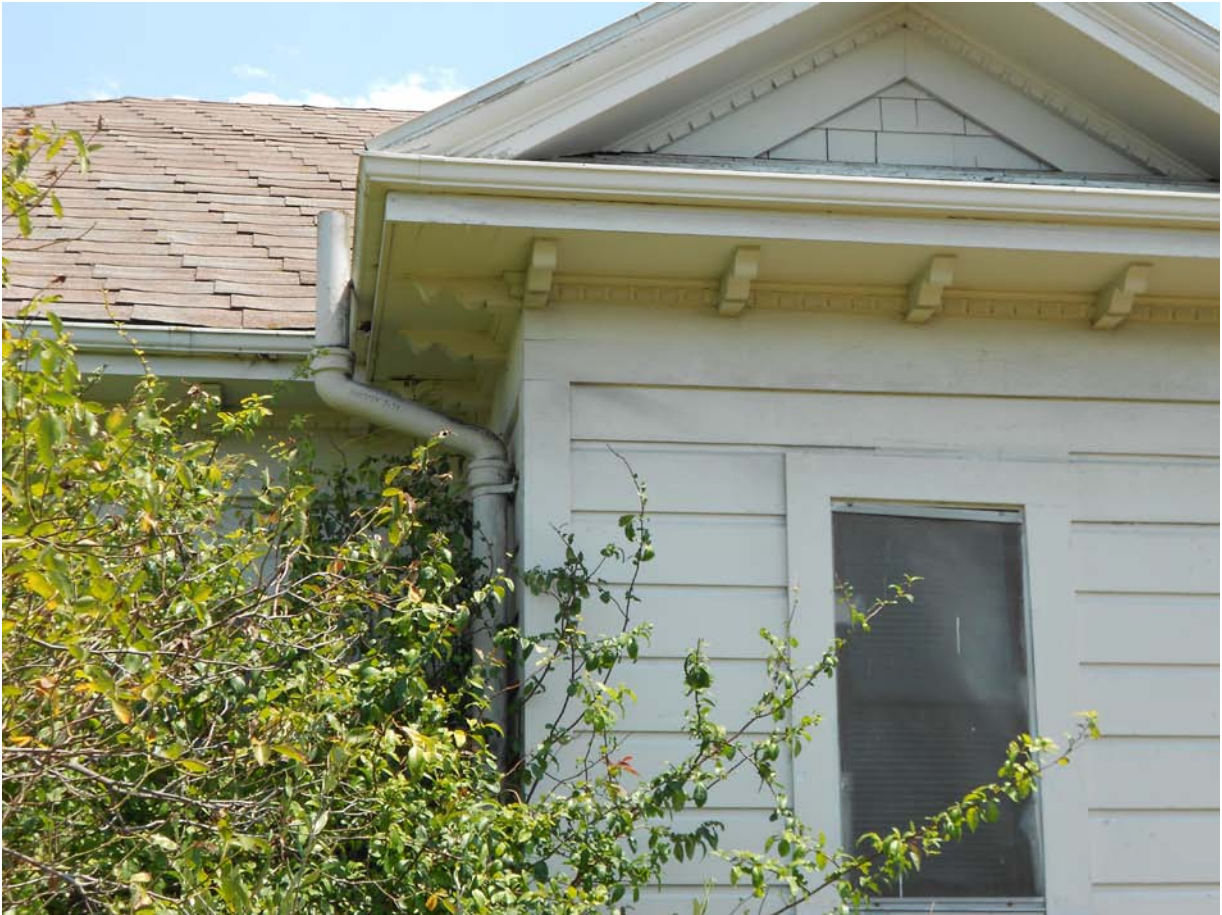
Figure 40: Detail of gable-roofed bathroom wing. Exterior mounted plumbing and exhaust should be rerouted. (July, 2014) (S&S)

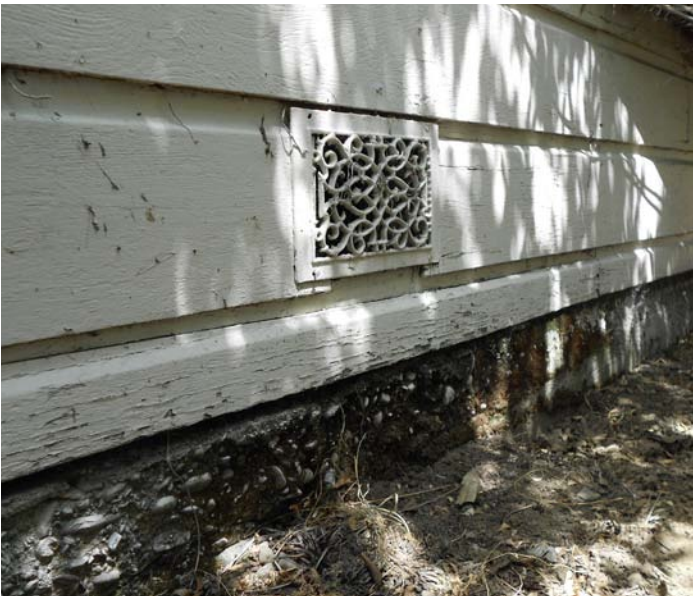
The wood ornament at the eaves and front porch appears to be intact and in good condition. However, some soffit boards are warped from water damage. Decorative iron grilles once covered the foundation vents. These are all now missing except in one location.

Figure 41: Decorative iron grille at foundation on west side of house. Only one grille is intact; all others are missing. (July, 2014) (S&S)

Replace decorative grille covers at foundation vents to match original.

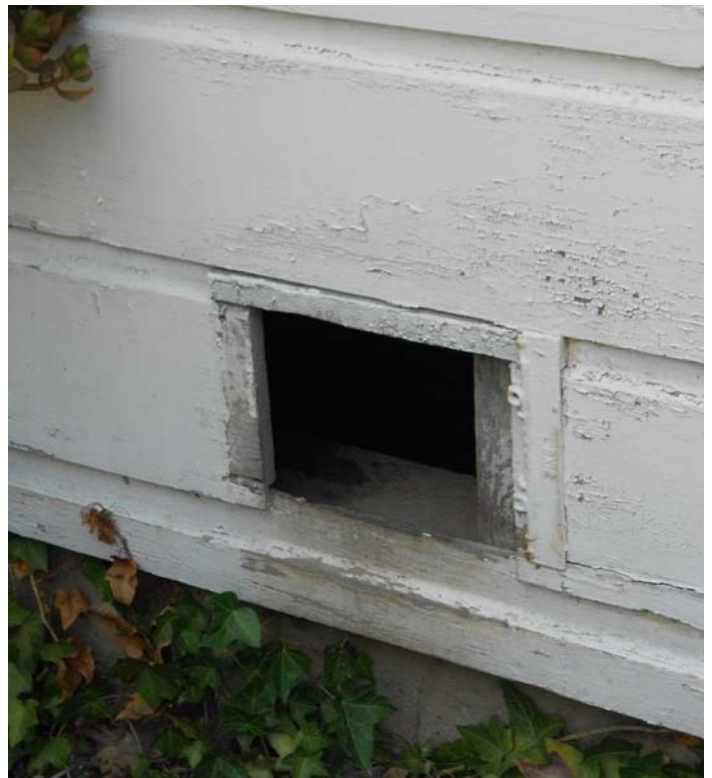
Figure 42: Foundation vent with missing grille. (July, 2014) (S&S)

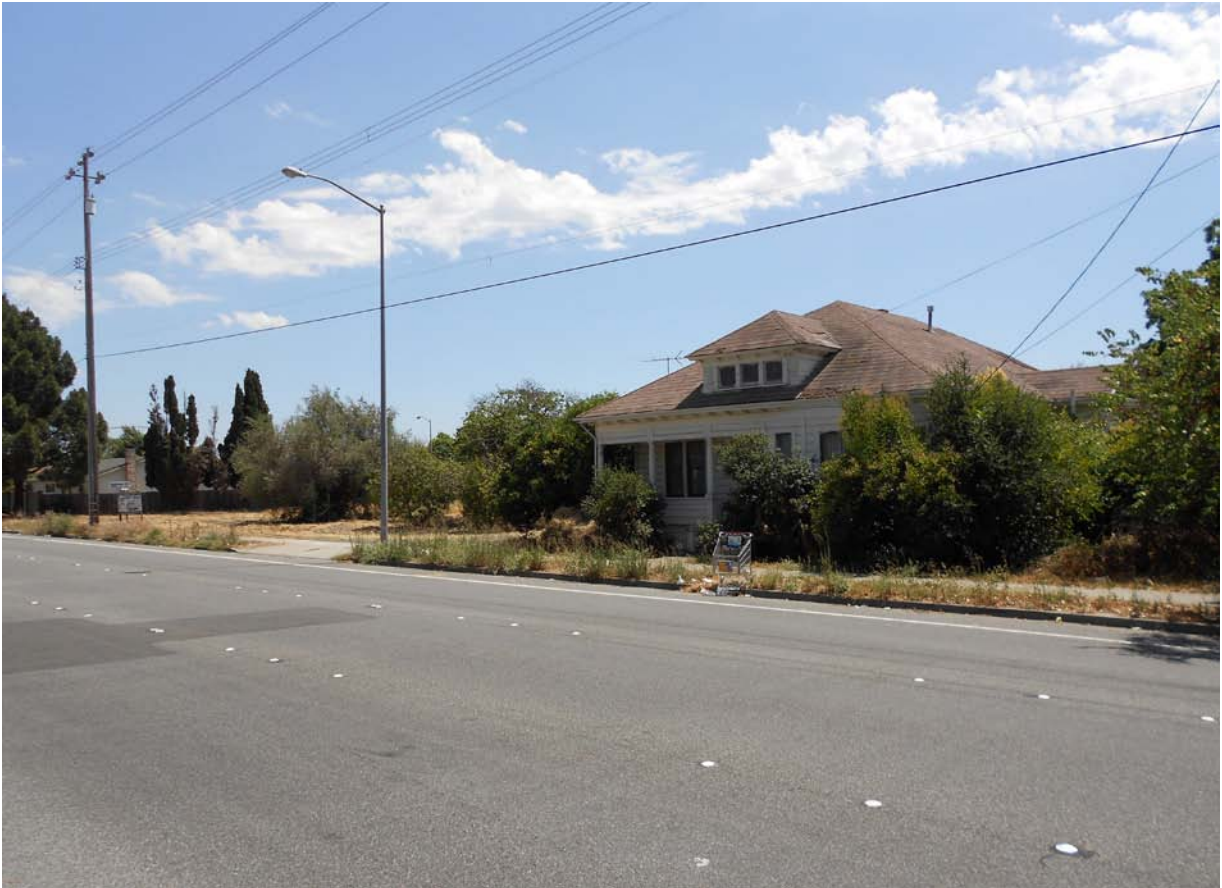
*Figure 43: House viewed from Fremont Boulevard, looking southeast. Overgrown vegetation obscures the house from public view and should be cut back and maintained. (July, 2014) (S&S)*

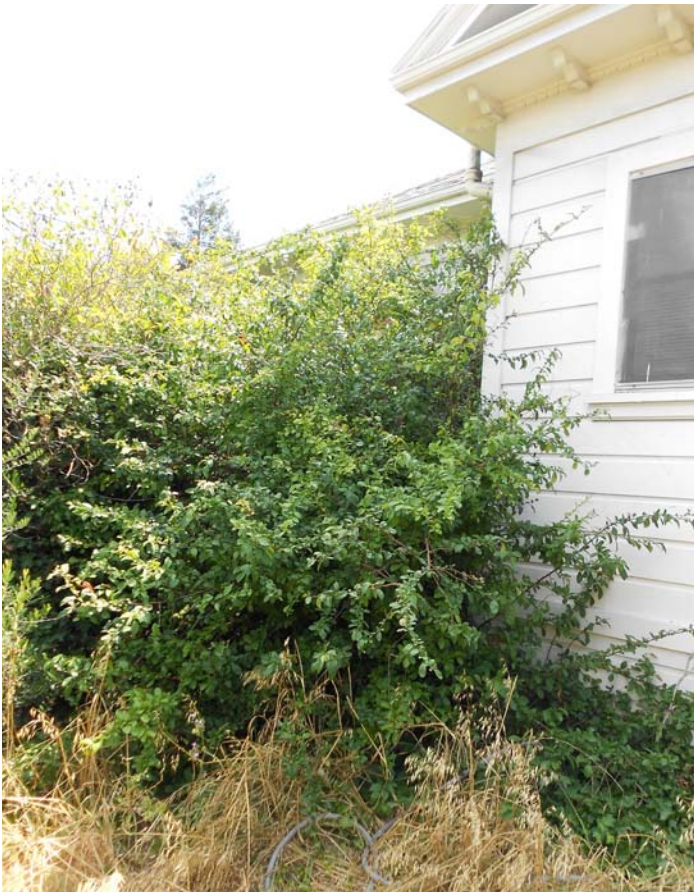
Figure 45: Overgrown vegetation at north end of west elevation. (July, 2014) (S&S)

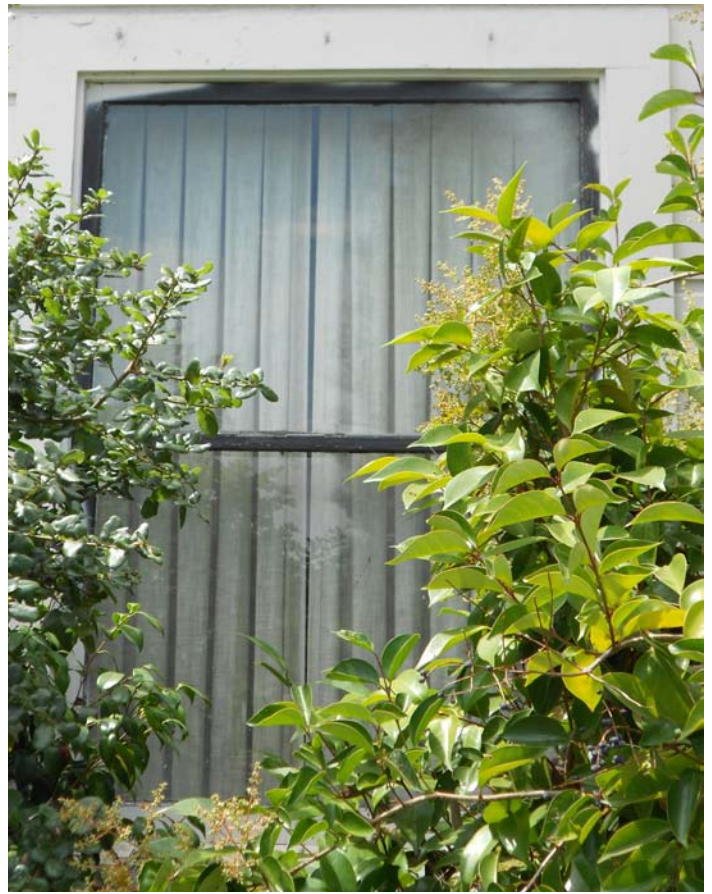
Figure 46: Overgrown vegetation at west end of front elevation. (July, 2014) (S&S)
